DEPARTMENT OF TRANSPORTATION**DIVISION OF ENGINEERING SERVICES**

Quality Assurance and Source Inspection

Contract #: 04-0120F4Cty: SF/ALA Rte: 80 PM: 13.2/13.9File #: 70.28**WELDING INSPECTION REPORT****Resident Engineer:** Pursell, Gary**Address:** 333 Burma Road**City:** Oakland, CA 94607**Report No:** WIR-004160**Date Inspected:** 16-Oct-2008**Project Name:** SAS Superstructure**OSM Arrival Time:** 2200**Prime Contractor:** American Bridge/Fluor Enterprises, a JV**OSM Departure Time:** 700**Contractor:** Japan Steel Works**Location:** Muroran, Japan**CWI Name:** Pan Han**CWI Present:** Yes No**Inspected CWI report:** Yes No N/A**Rod Oven in Use:** Yes No N/A**Electrode to specification:** Yes No N/A**Weld Procedures Followed:** Yes No N/A**Qualified Welders:** Yes No N/A**Verified Joint Fit-up:** Yes No N/A**Approved Drawings:** Yes No N/A**Approved WPS:** Yes No N/A**Delayed / Cancelled:** Yes No N/A**Bridge No:** 34-0006**Component:** Tower, Deviation and Jacking Saddles**Summary of Items Observed:**

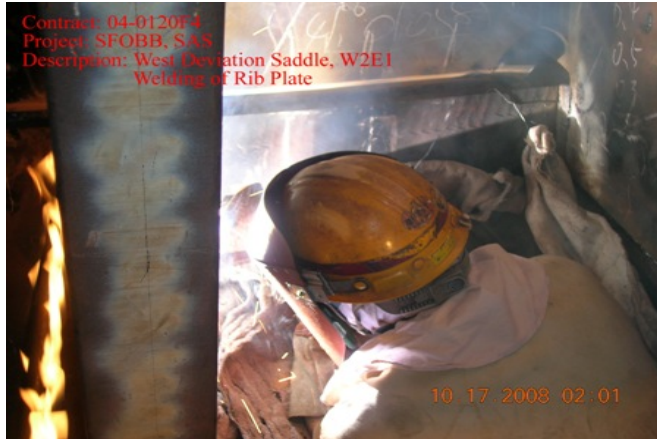
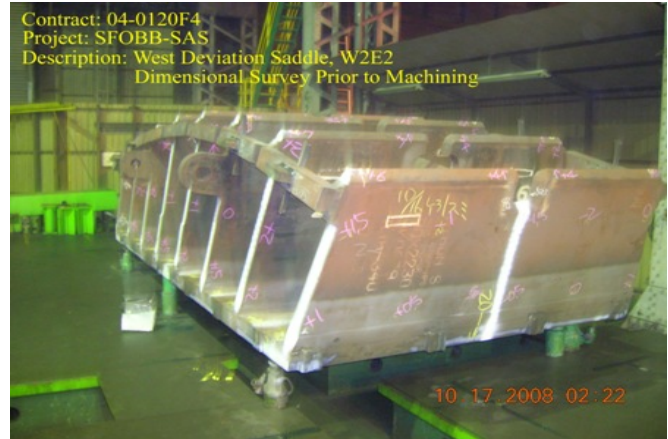
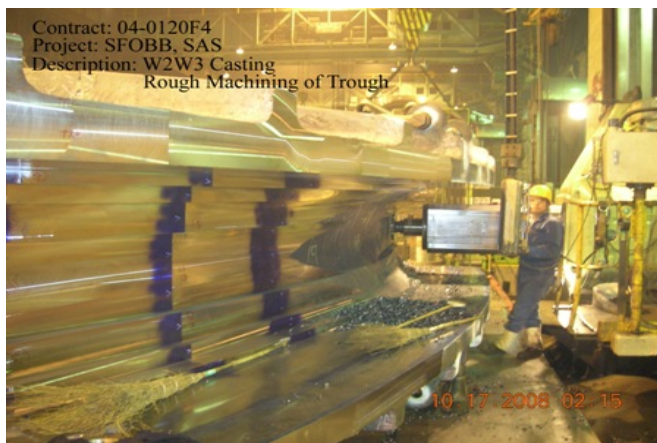
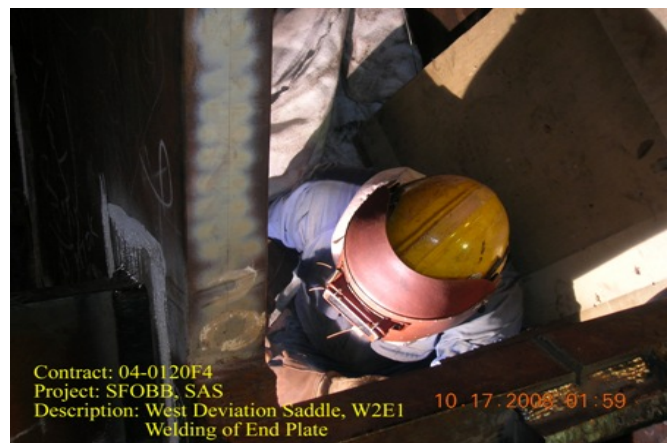
At the start of the shift the QA inspector observed the scheduled Partial Joint Penetration (PJP) groove welding of the structural steel grillage to the casting, QC inspection and the verification of the Alternating Current (AC) and the Direct Current (DC) welding parameters on the structural steel plate components for the West Deviation Saddle identified as W2E1. The welding was performed on the rib to rib connections identified as E1Y-12U, E1Y-14U, E1Y-15U, E1Y-16U and E1Y-17U-2. The welding was performed by Japan Steel Works, Ltd. (JSW) welding personnel Kato Makoto ID 08-5018, Yamashita Masao ID 73-4195 and Kubota Mamoru ID 74-3666.

At approximately 02:30 the QA inspector traveled to the machine shop and was escorted by JSW personnel Kunio Nagaya. The QA inspector observed the Tower Saddle Grillage identified as T1-1 was in final stages of the dimensional survey prior to the machining of the rib and stem plate at areas designated as "Mill to Bear." The QA inspector also observed the rough machining of the troughs on the Casting Saddle identified as W2E3. No work was performed on the Tower Saddle Grillage identified as T1-1 at the time of observation.

Later in the shift the QA inspector traveled to the machine shop and was escorted by JSW personnel Kunio Nagaya. The QA inspector observed the West Deviation Grillage identified as W2E2 was in the early stages of a dimensional survey prior to the machining of rib and stem plates at areas designated as "Mill to Bear." No work was performed on the W2E2 Grillage at the time of observation.

The digital photographs on page 3 of this report illustrates the observations of the activities performed on this date.
